MACUDA AMERICA PROJECT COMMITTEE

WATER SYSTEM PROJECT SURVEY – 2025

Prepared by Jones Nji Nkimbeng

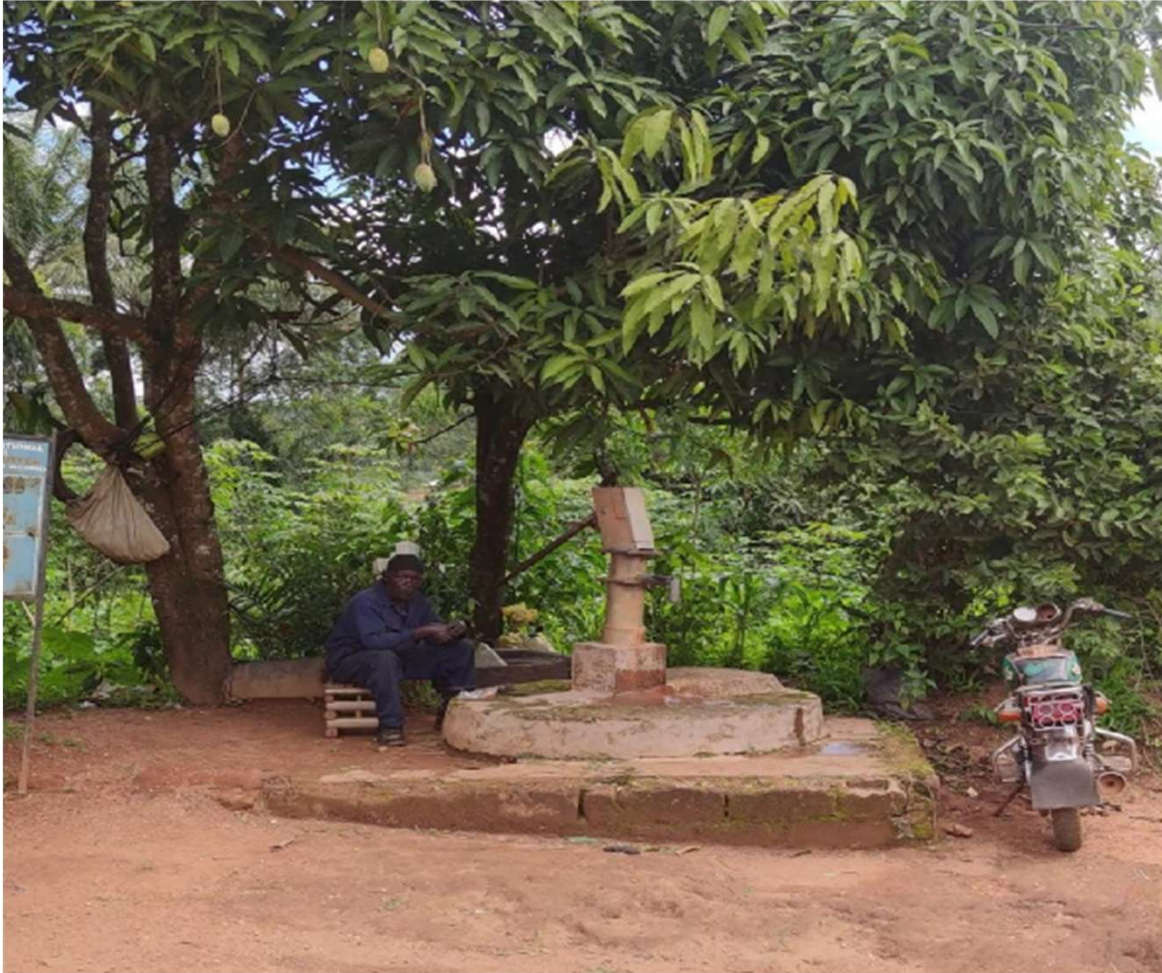
SURVEY RESULTS OF PUBLIC WATER SYSTEMS - CHINDE

Hand-dug well with a manual hand pump.

Not functional

Faulty center rod - Faulty Pipes

Replacement of faulty parts; - Possible increase of depth if necessary; - Cleaning and treatment; - Enclosure of fetching area

Estimated cost of maintenance = 300,000 - 800,000 cfa

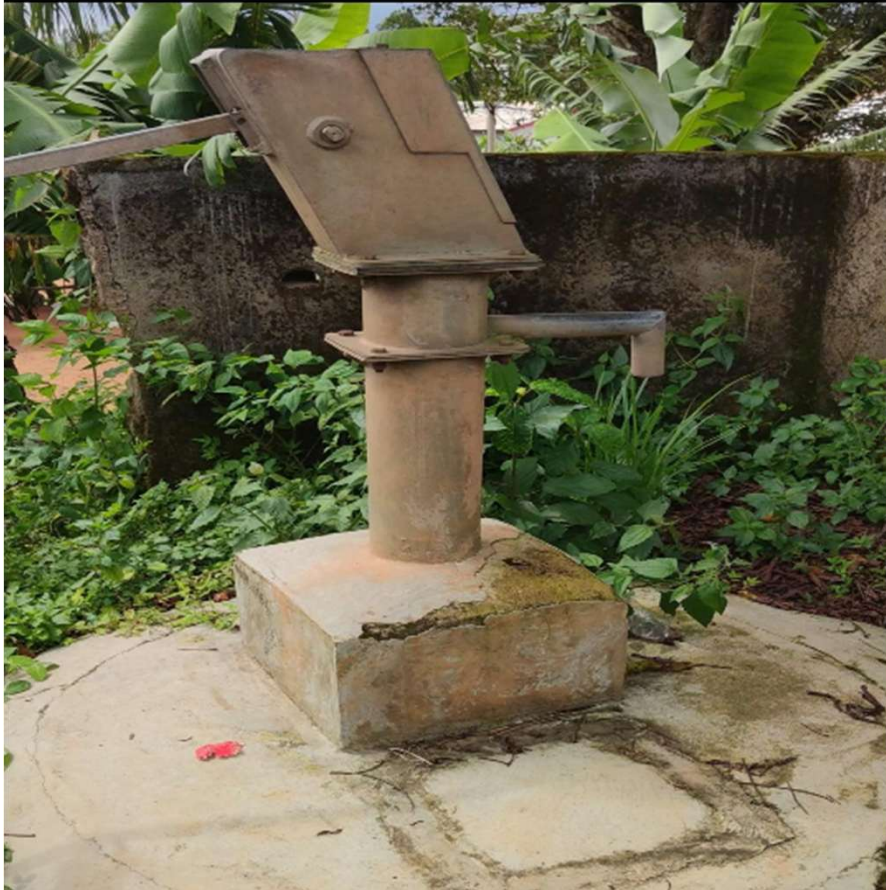
SURVEY RESULTS OF PUBLIC WATER SYSTEMS - **NTSUALAM**

Hand-dug well with a manual hand pump. Does not require a borehole machine.

Not functional for at least 5 years

Faulty center rod - Faulty Pipes - Faulty manual pump

Replacement of faulty parts; - Possible increment of depth if necessary; - Cleaning and treatment; - Reconstruction of enclosure of fetching area

Estimated Maintenance :400,000 - 900,000 CFA

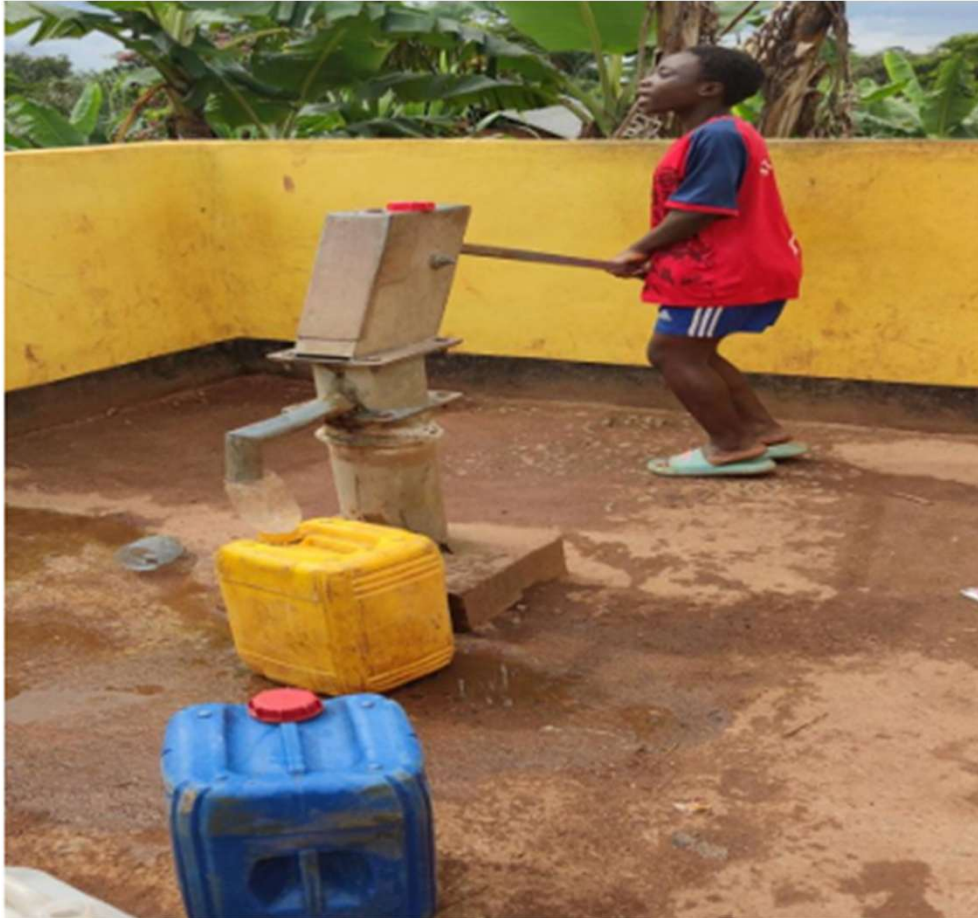
SURVEY RESULTS OF PUBLIC WATER SYSTEMS - ALATAKOR

Borehole with a manual hand pump

Fully Functional

Stressful to operate hand pump

Installation of a foot valve for water retention and mounting of water pressure for easy and less stressful use

Estimated Maintenance: 100,000 - 200,000 CFA

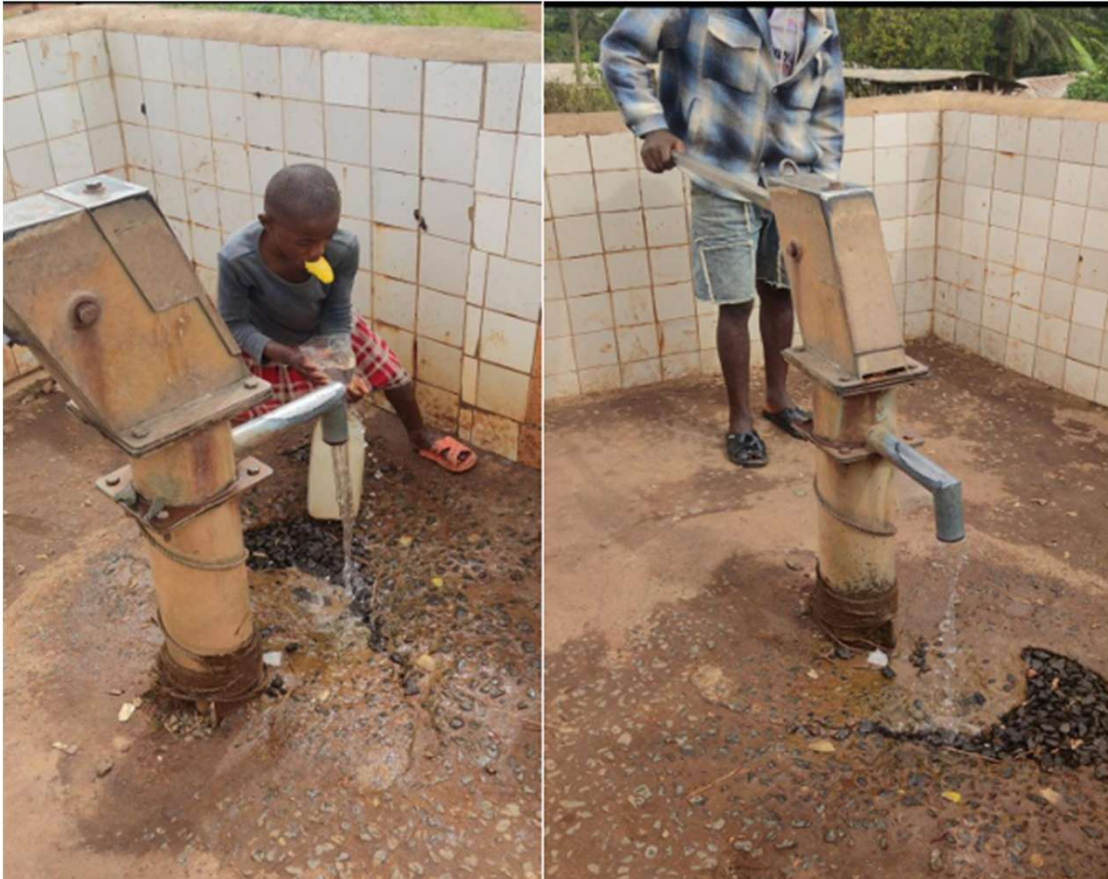
SURVEY RESULTS OF PUBLIC WATER SYSTEMS - ALABUKAM

Borehole with a manual hand pump

Fully Functional

No Problem

The water system needs little or no maintenance. Possible maintenance of the concrete slab needed.

Estimated Maintenance: 5,000 - 25, 000 CFA

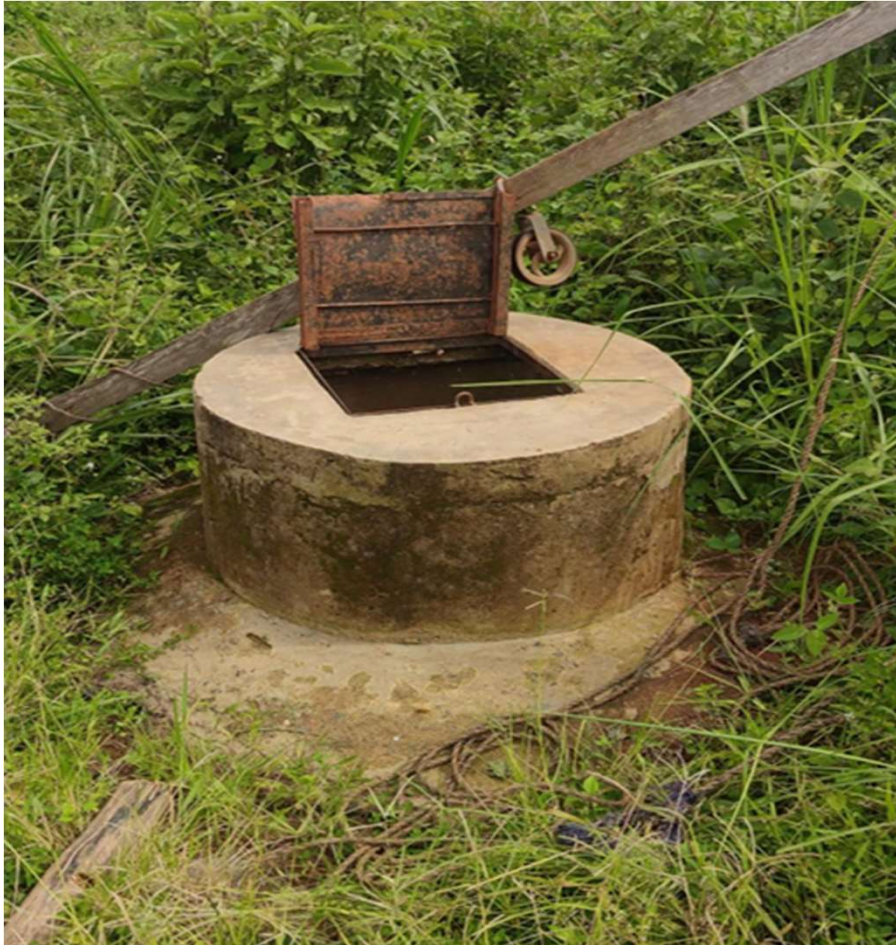
SURVEY RESULTS OF PUBLIC WATER SYSTEMS – **ASONGKA – ALABUKAM HEALTH CENTER**

Hand-dug well without a manual hand pump. Does not require a borehole machine.

Not functional but water can be fetched from the well by means of a rope and bucket

Lack of pumping system

Installation of complete manual hand pump; - Possible increase of depth if necessary; - Cleaning and treatment; - Construction of an enclosure around the fetching area

Estimated Maintenance: 600,000 - 1, 200, 000 CFA

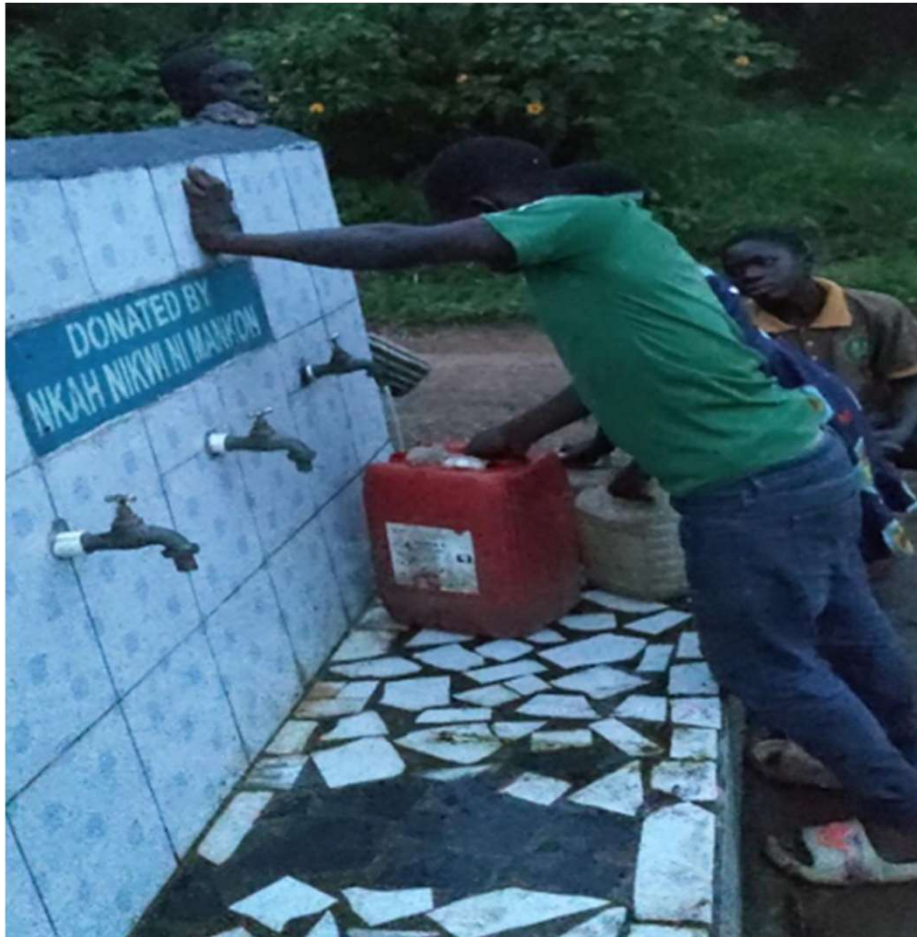
SURVEY RESULTS OF PUBLIC WATER SYSTEMS – **ASONGKA – ALABUKAM HEALTH CENTER**

Hand-dug well with one stand tap and a constructed tower carrying a 2m³ tank and system operated by an electric pump. This was donated by NKAH NIKWI NI MANKON. Borehole machine not required.

Functional

Water shortage always experienced ; Unstable electrical supply

Possible increase of depth if necessary; - Cleaning and treatment
(Need approval/collaboration with Nkah Nikwi of Mankon)

Estimated Maintenance: 100,000 - 300, 000 CFA

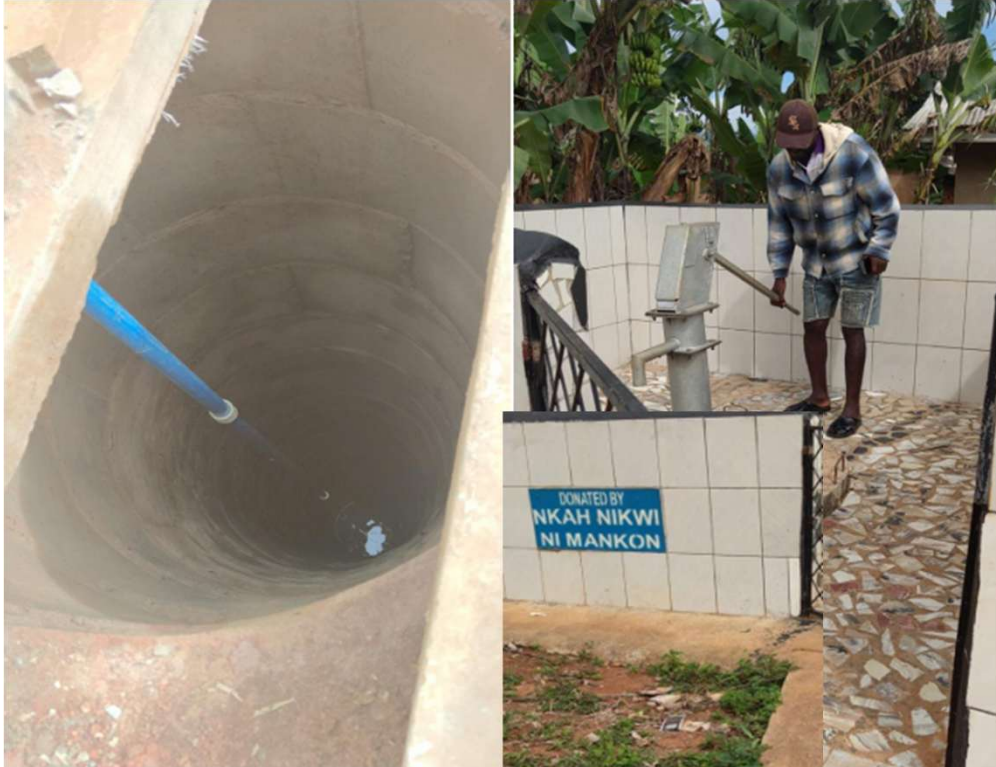
SURVEY RESULTS OF PUBLIC WATER SYSTEMS – ALAHNKIE

Hand-dug well with a manual hand pump donated by NKAH NIKWI NI MANKON. Does not require a borehole machine.

Not Functional

Faulty center rod

Replacement of broken center rod (***Need to approval/collaboration with Nkah Nikwi***)

Estimated Maintenance: 50,000 - 100,000 CFA

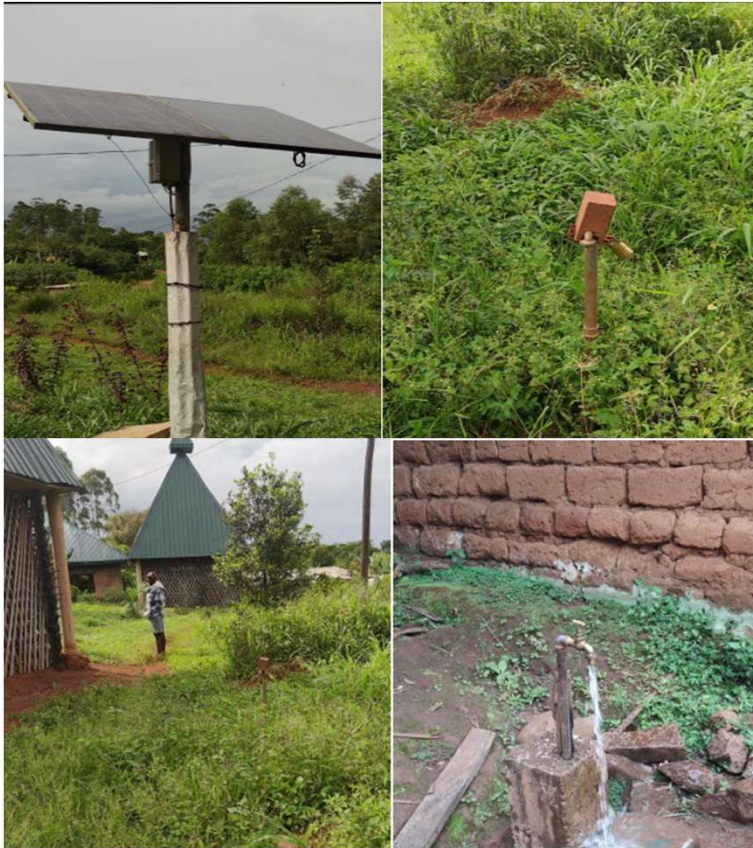
SURVEY RESULTS OF PUBLIC WATER SYSTEMS – ALAHNKIE – DAY NO BE ONE AT LISHEY'S RESIDENCE

Borehole powered by a solar system but with no storage

Partially Functional, one failed tap, two taps total

One Failed tap

Replacement of failed tap head (**Approval/Agreement**)

Estimated Maintenance: 5,000- 25, 000 CFA

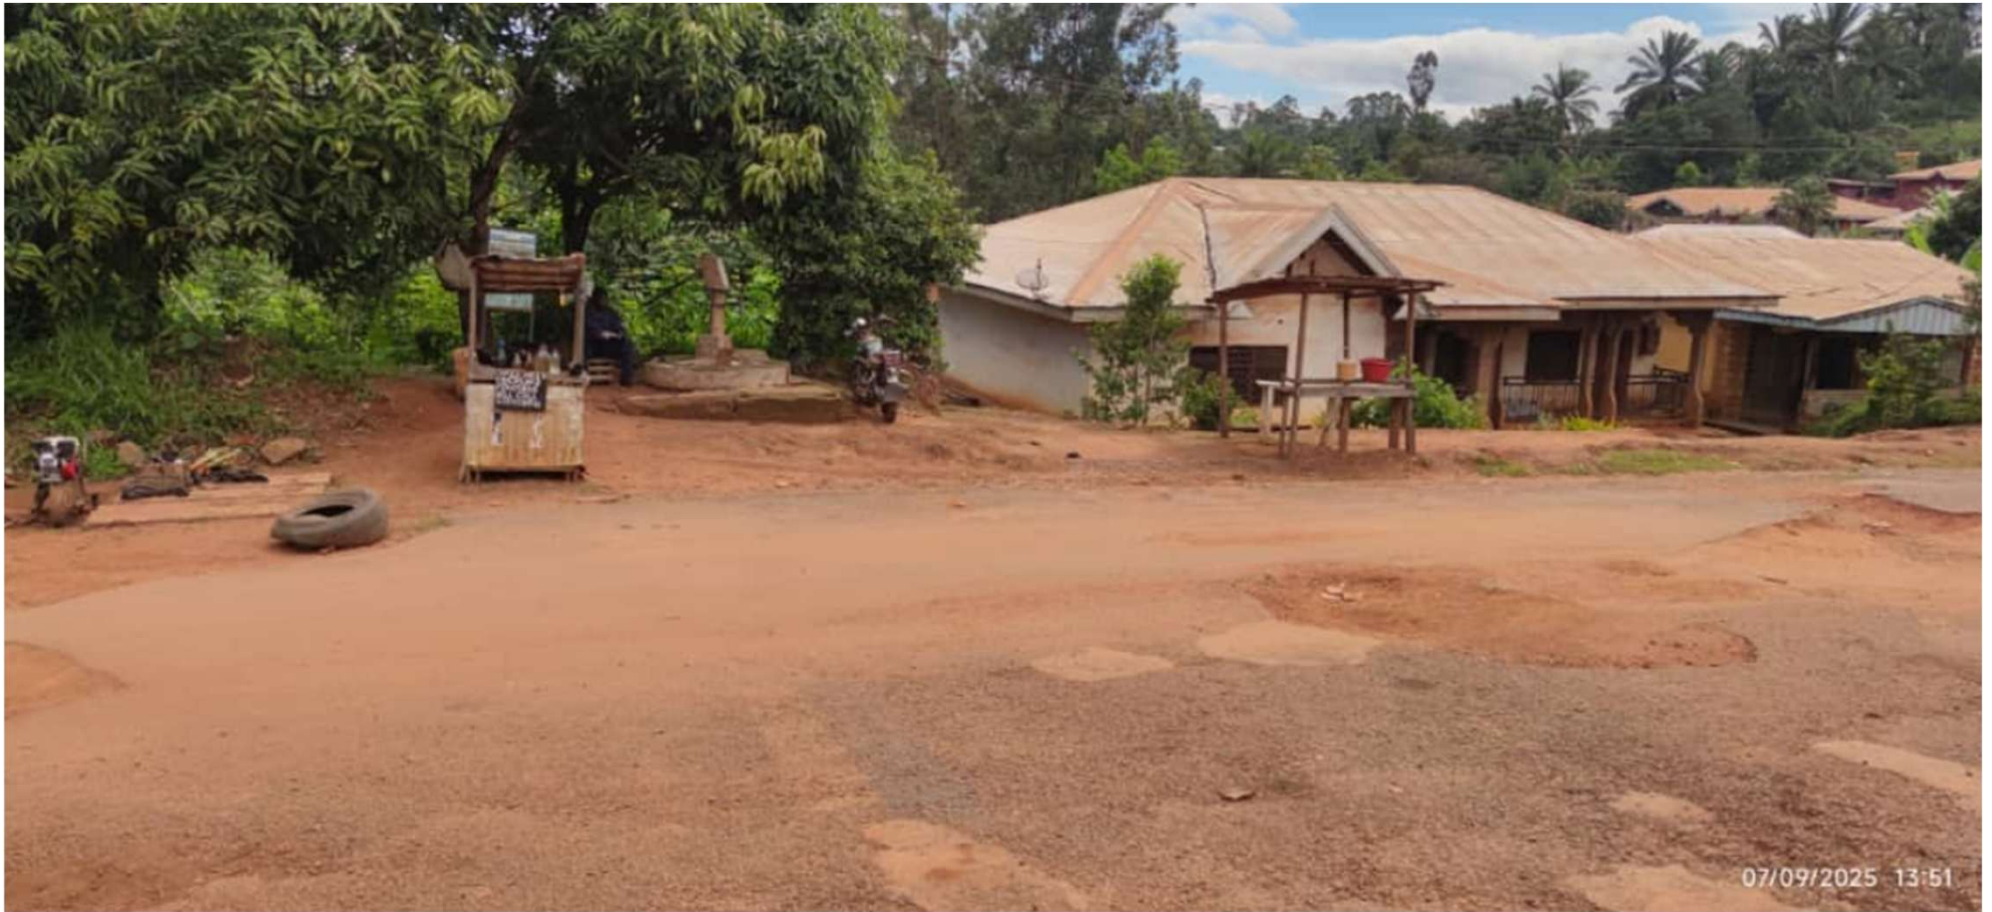
ADDITIONAL PICTURES – A WIDER VIEW OF THE PUBLIC HAND PUMP AT CHINDE

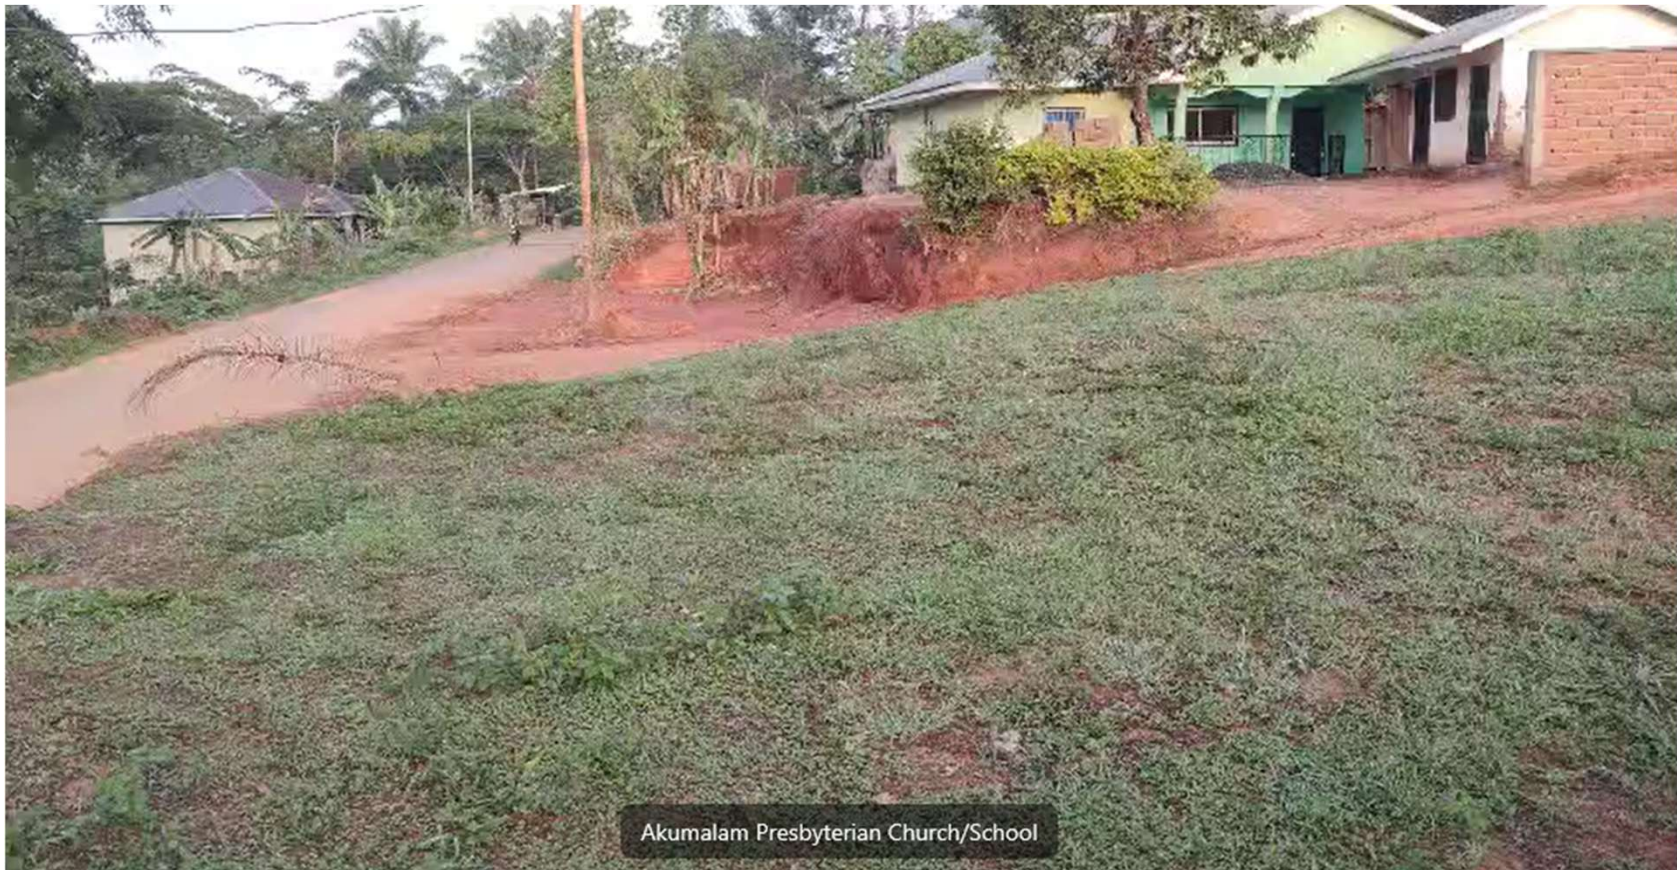
ADDITIONAL PICTURES – AKUMALAM PRESBYTERIAN CHURCH – A BOREHOLE SYSTEM AT NSTUALAM WOULD SUPPLY AKUMALAM AND NEIGHBORING QUARTERS

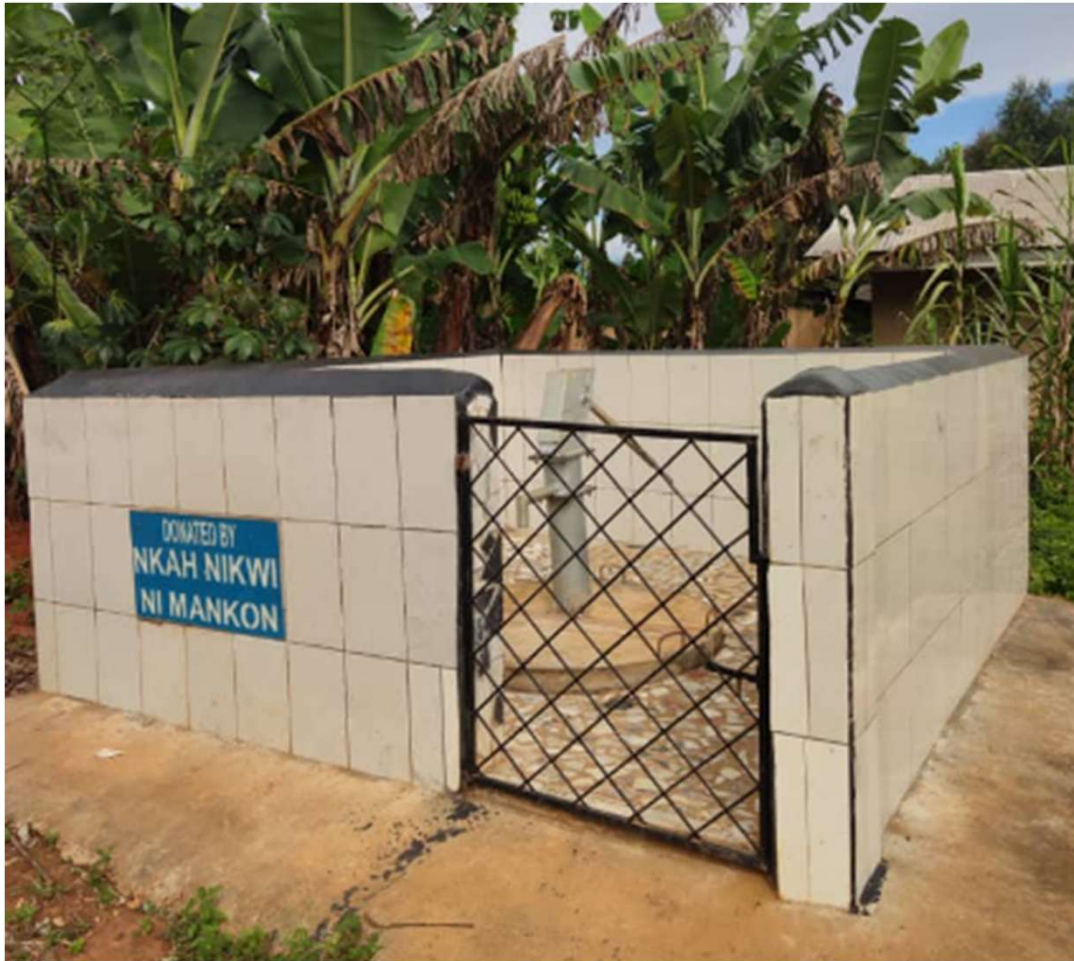
ADDITIONAL PICTURES – NKAH NIKWI HAND-DUG WELL AT ALAHNKIE – A BOREHOLE MACHINE WAS NOT NEEDED

- Existing wells should be improved and sealed of the prevent contamination (Intentional or Inadvertent). This applies to existing wells at Alabukam and Alankie
- Access should be by authorized and competent Persons ONLY

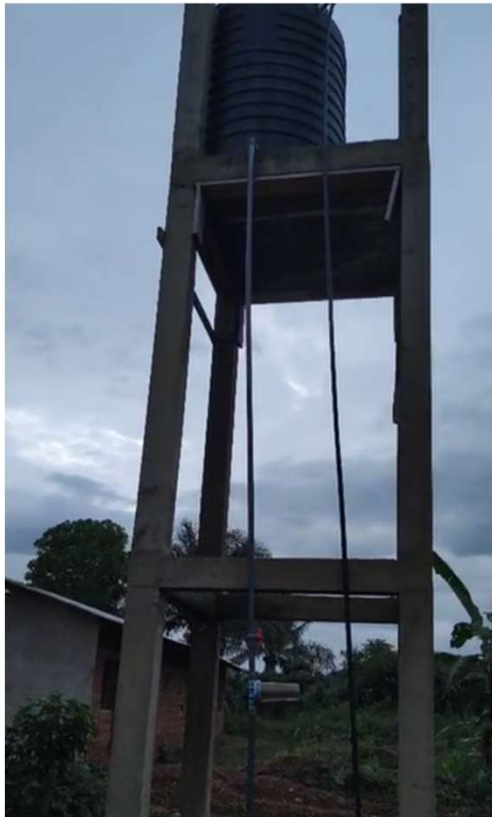
ADDITIONAL PICTURES – 2000-L TANK TOWER AT ALABUKAM HEALTH CENTER (S-BEND)

AN ELECTRIC PUMP INSIDE THE NKAH NIKWI WELL NEARBY PUMPS WATER INTO THIS TANK. THE TANK SUPPLIES WATER BY GRAVITY TO THE HOSPITAL AND COMMUNITY. THIS SYSTEM CAN BE UPGRADED AS EXPLAINED ABOVE

2000 L Tank at Alabukam Health Center

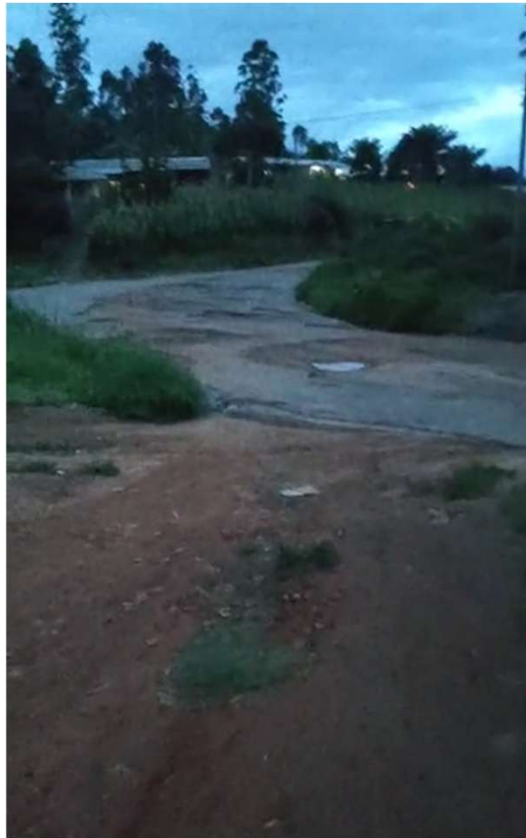
Nkwa Nikwi Well at S-Bend

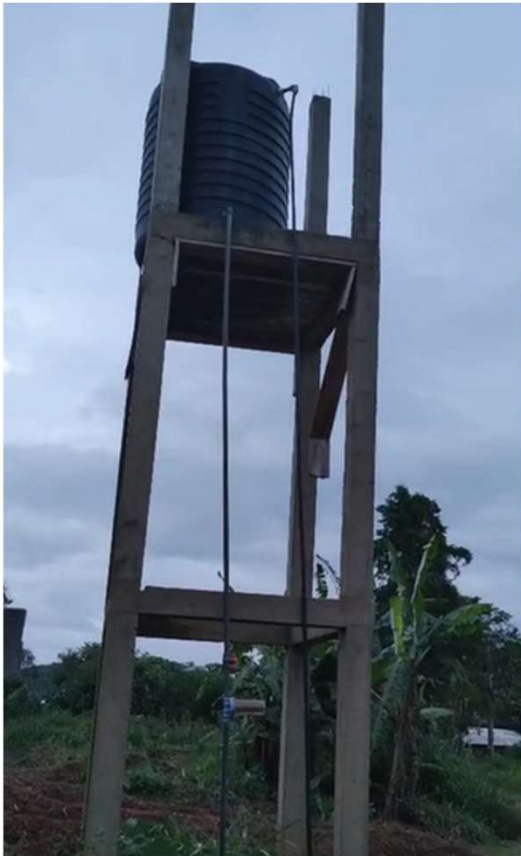
AN ELECTRIC PUMP INSIDE THE NKAH NIKWI WELL NEARBY PUMPS WATER INTO THIS TANK. THE TANK SUPPLIES WATER BY GRAVITY TO THE HOSPITAL AND COMMUNITY. THIS SYSTEM CAN BE UPGRADED AS EXPLAINED ABOVE

The Tank needs to be centered

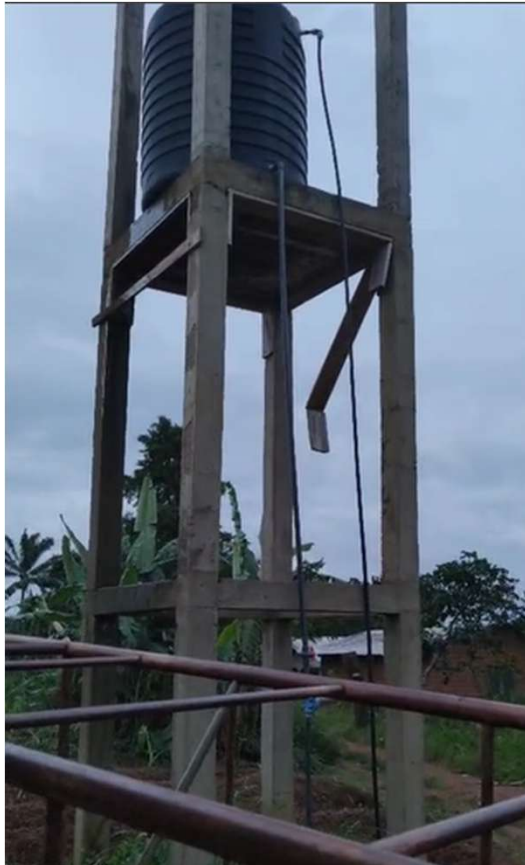
The Tank needs to be centered

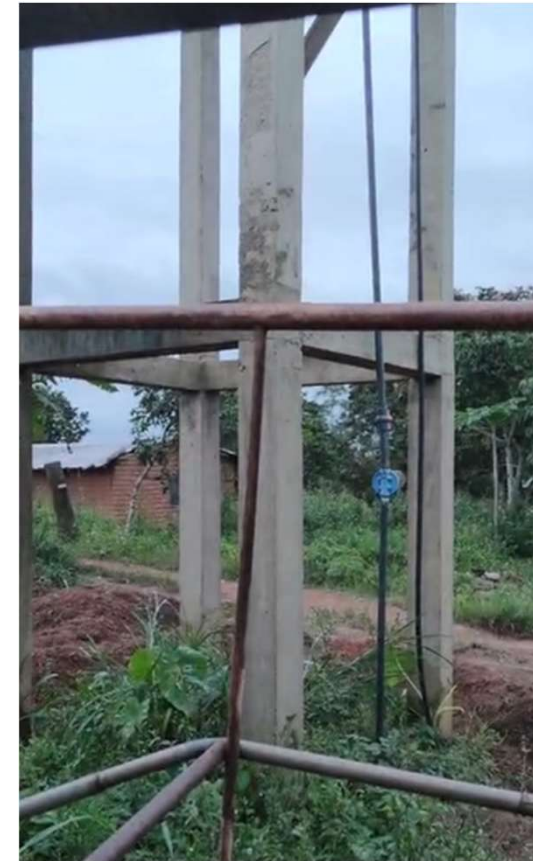
The tank was original supported by a metal structure

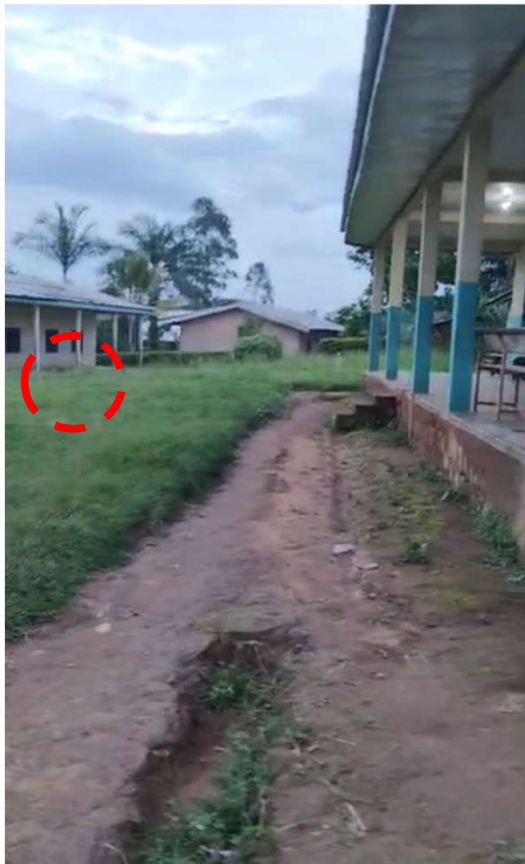
IT IS REPORTED THAT TWO BOREHOLES WERE DUG BUT ABANDONED DUE TO THE SALTY NATURE OF THE WATER. FURTHER INVESTIGATION IS NEEDED

Location of an abandoned Borehole
infront of the Health Center

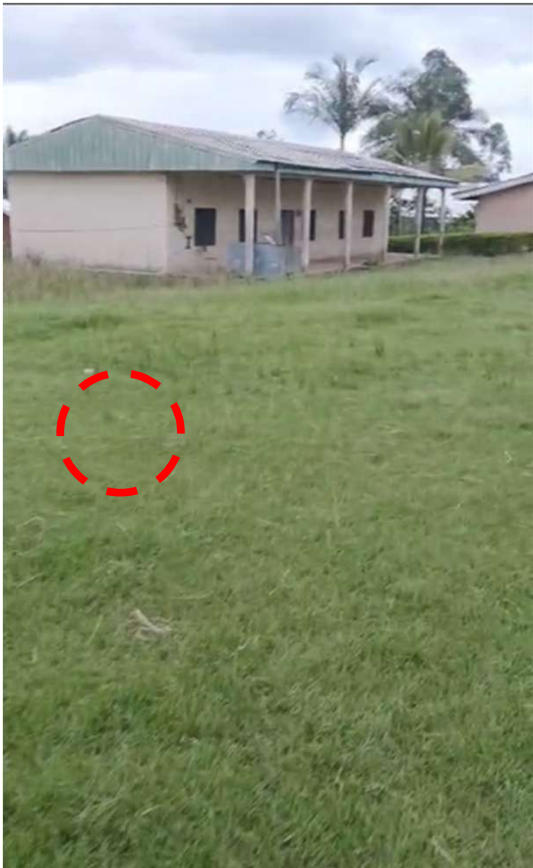
IT IS REPORTED THAT TWO BOREHOLES WERE DUG BUT ABANDONED DUE TO THE SALTY NATURE OF THE WATER. FURTHER INVESTIGATION IS NEEDED

Alabukam Health Center – Location of the second borehole that was abandoned

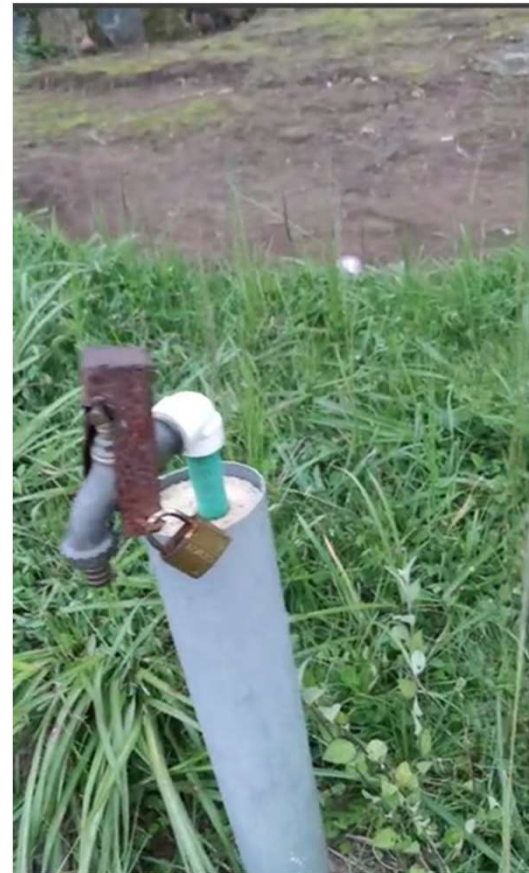
Alabukam Health Center – A public tap in front of the building (Needs repairs)

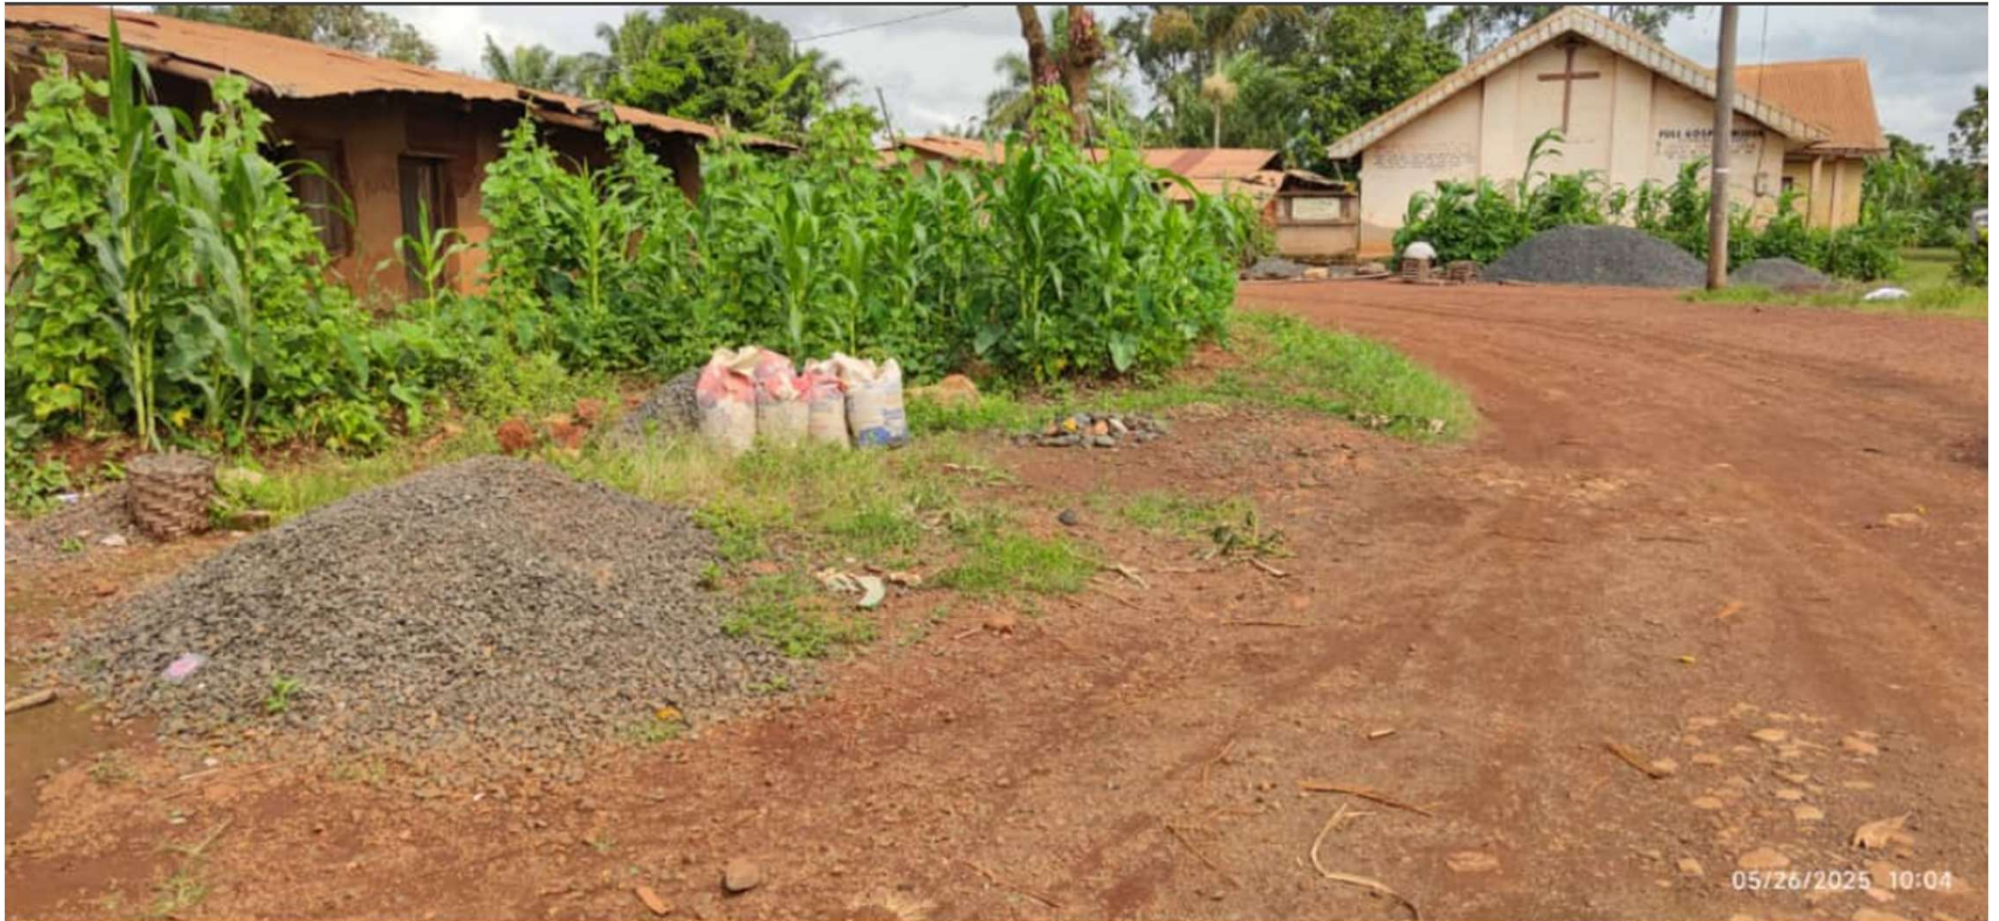
ADDITIONAL PICTURES – NTAMBENG II – NO PUBLIC TAPS

PROPOSED LOCATION OF THE BOREHOLE SYSTEM AT NTAMBENG II
